**NEW BRITAIN BOROUGH
2017 ROADWAY CONDITION PLAN
AND
5 YEAR RECONSTRUCTION PLAN**

November 8, 2017

**REPORT OF
PAVEMENT EVALUATIONS**

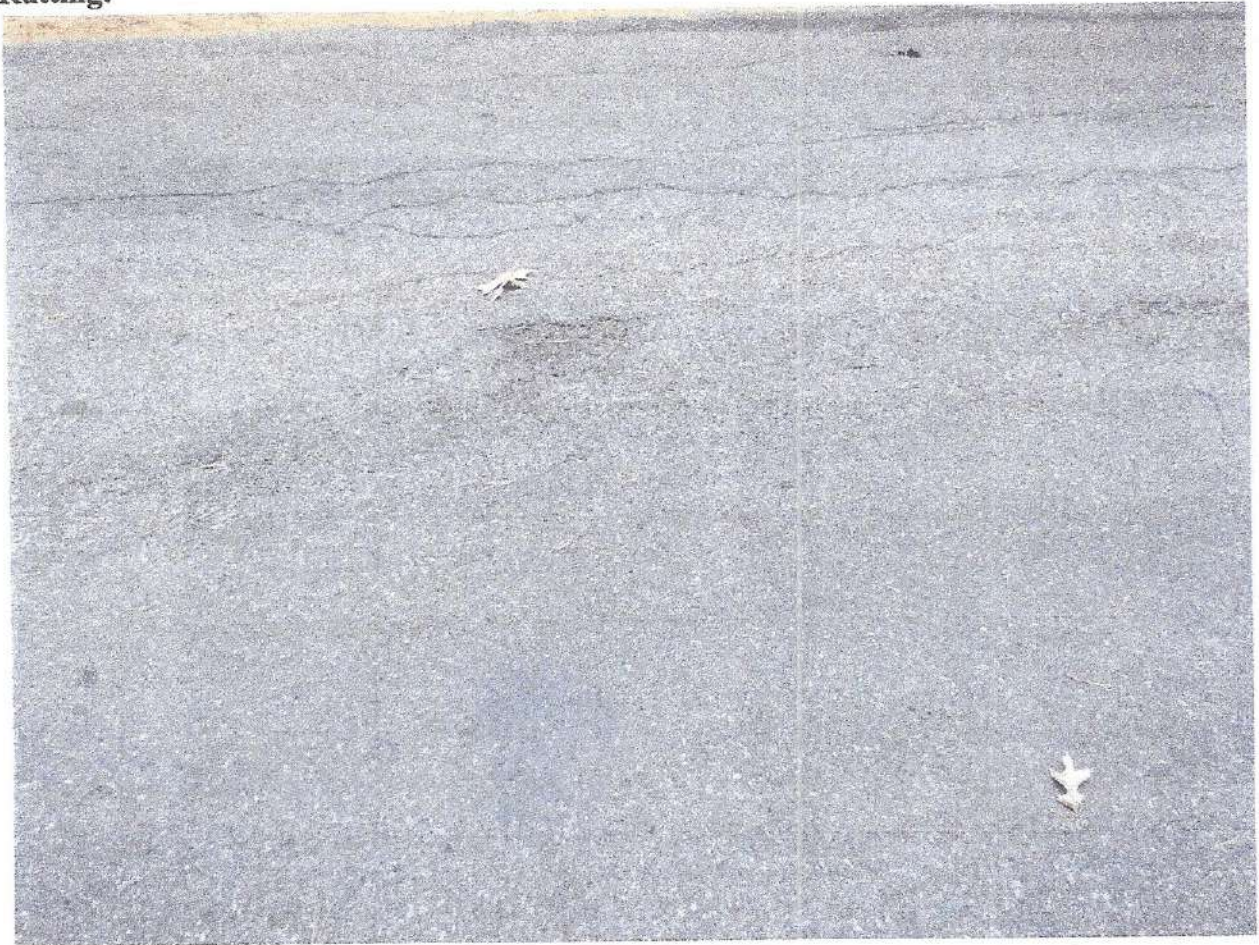
Rutting:

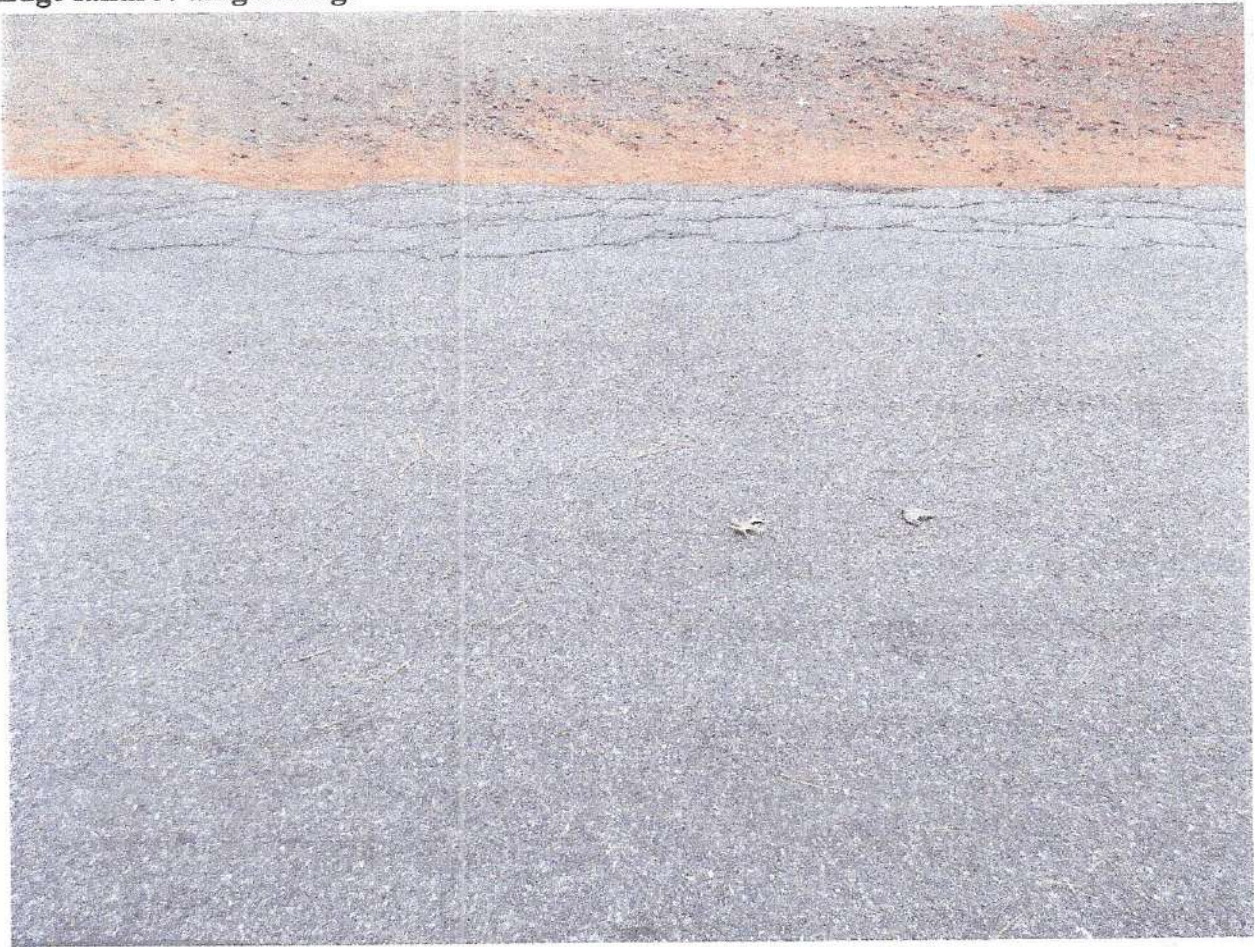
Edge failure / alligatoring:

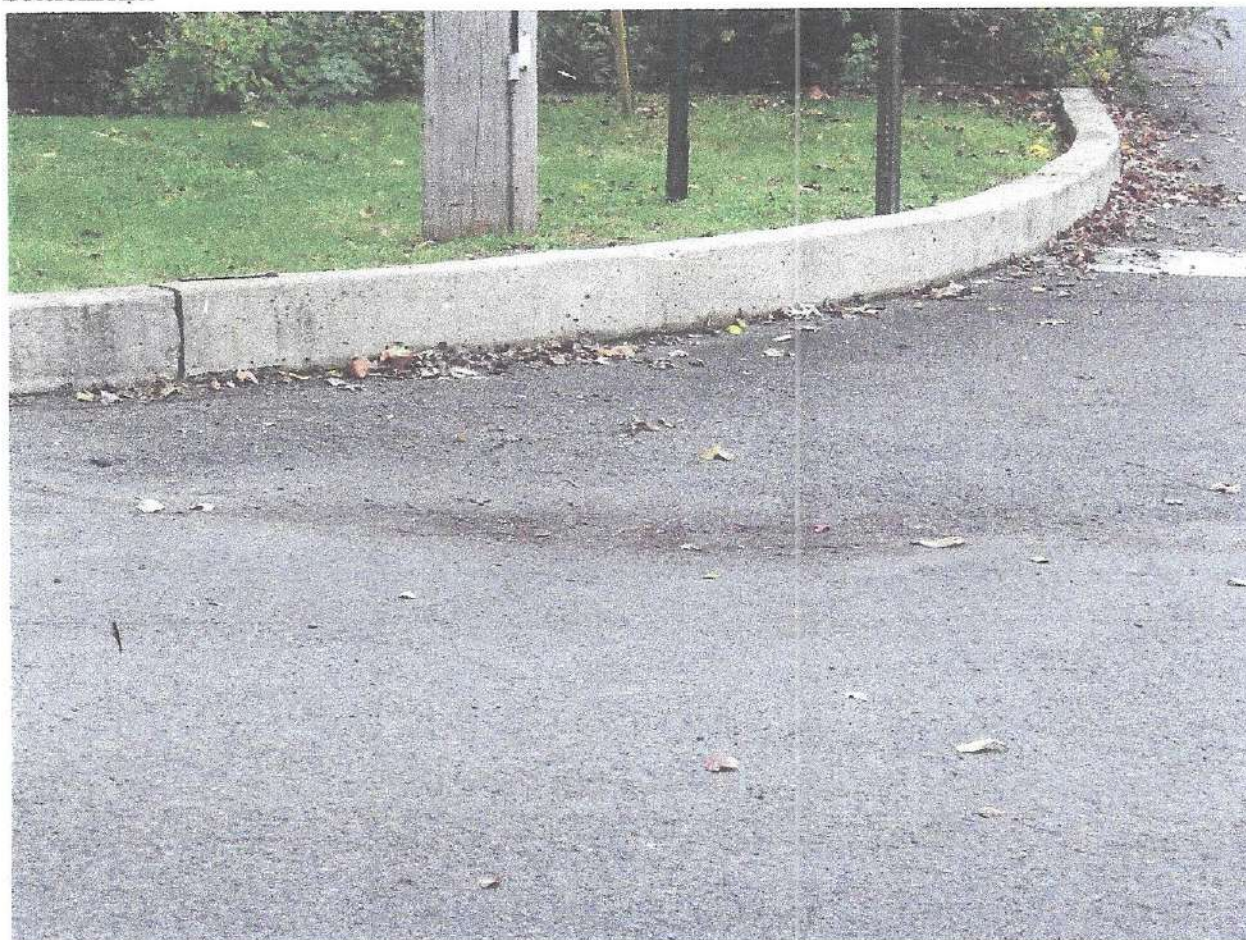
Settlement:

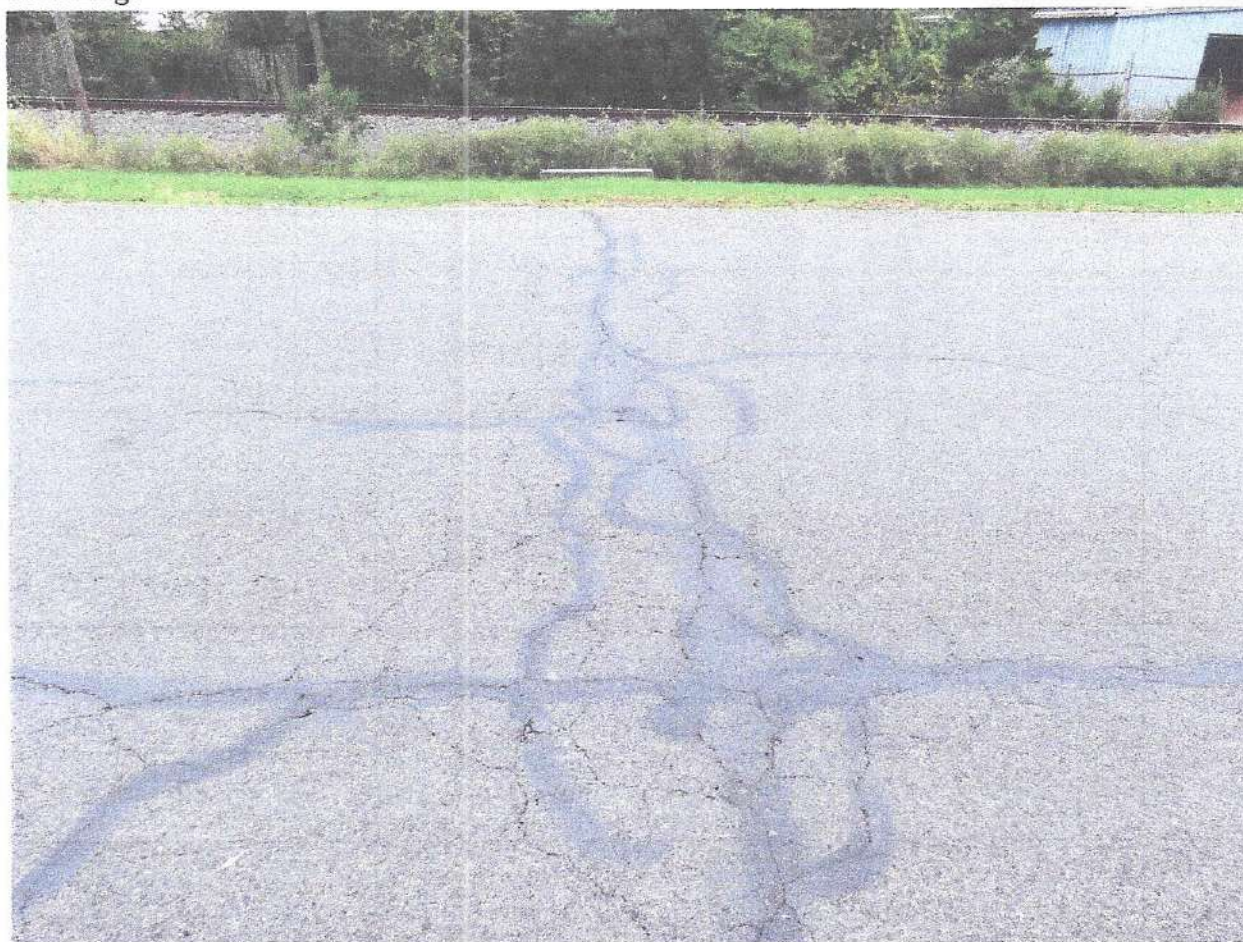
Cracking:

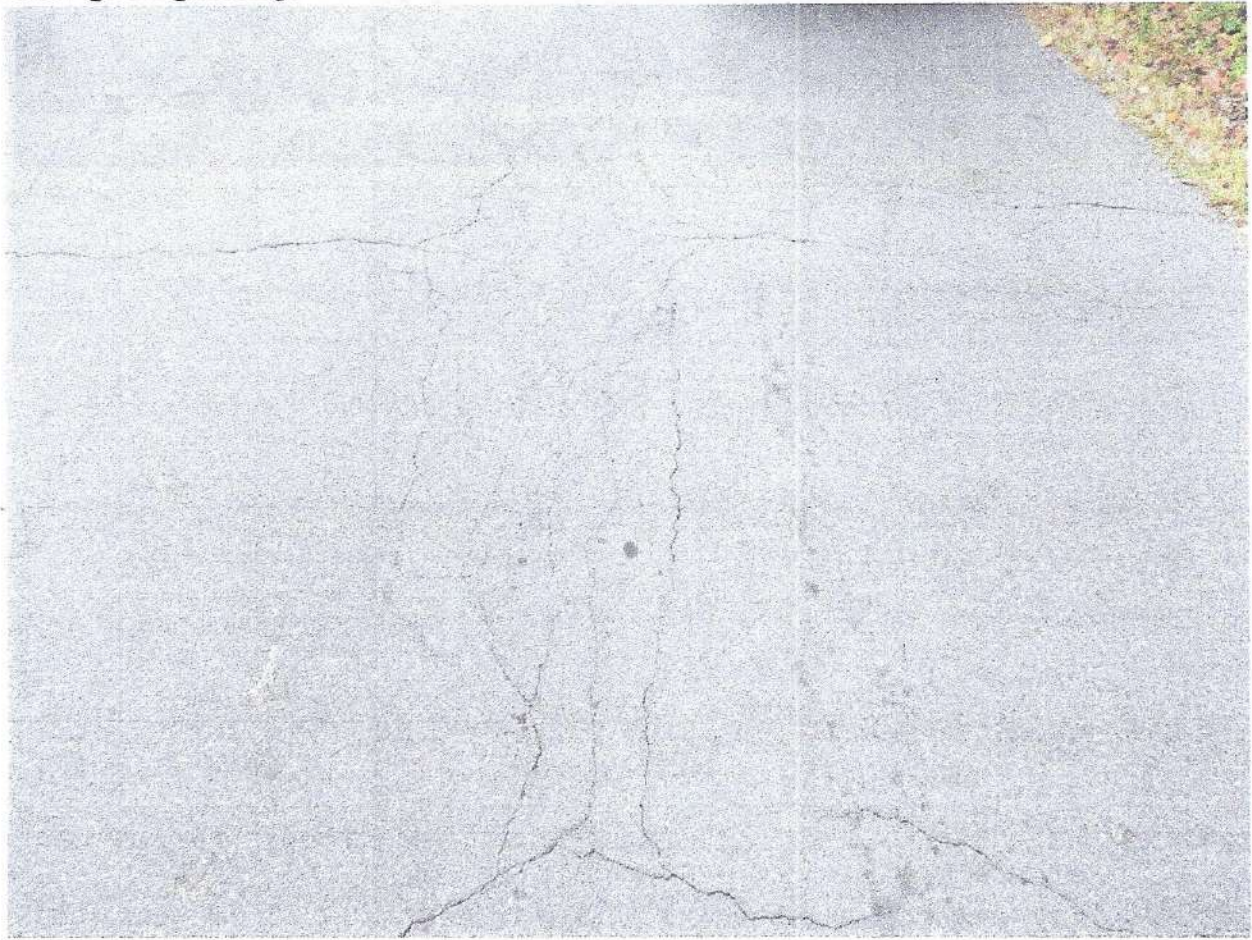
Rutting / alligatoring:

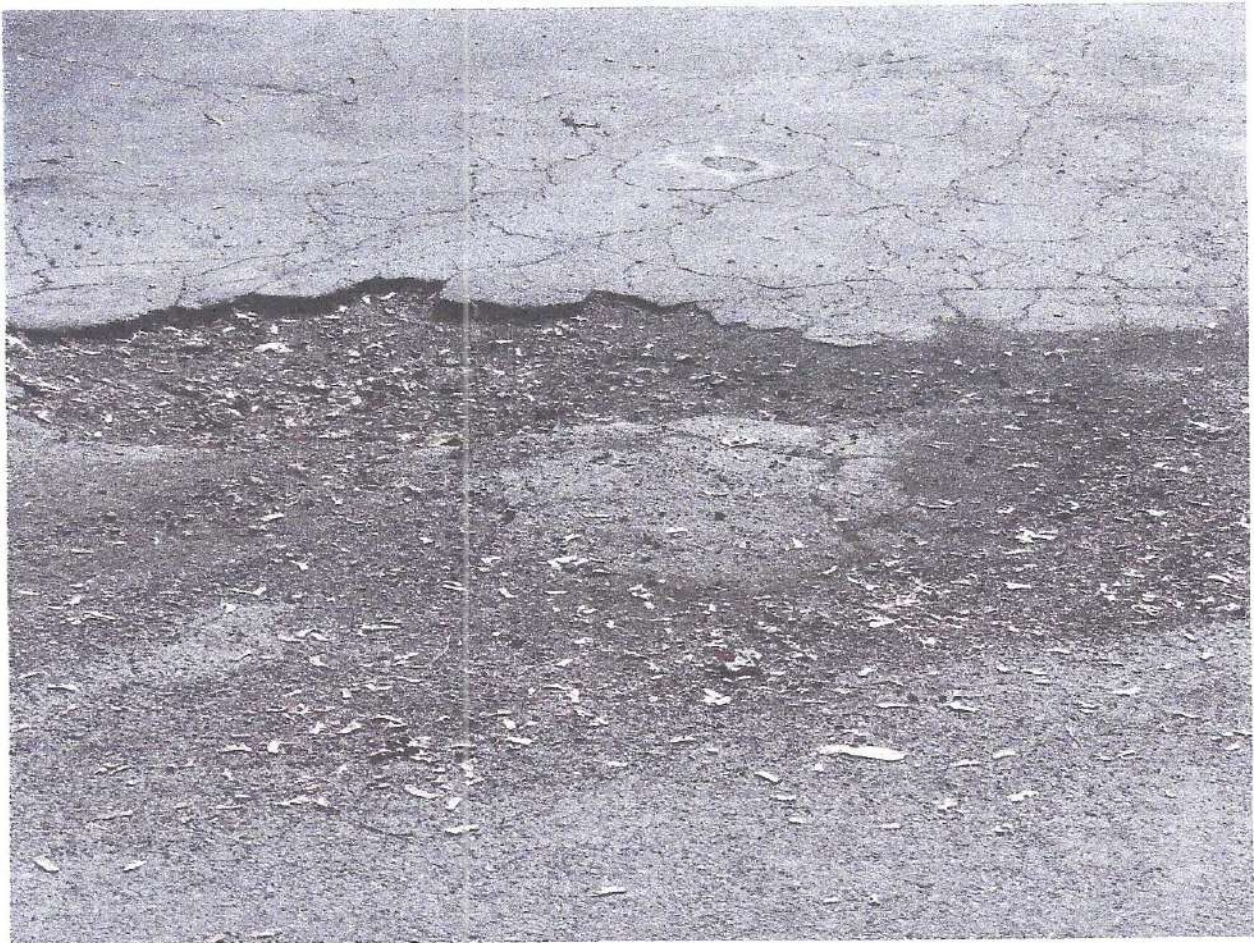
Pothole:

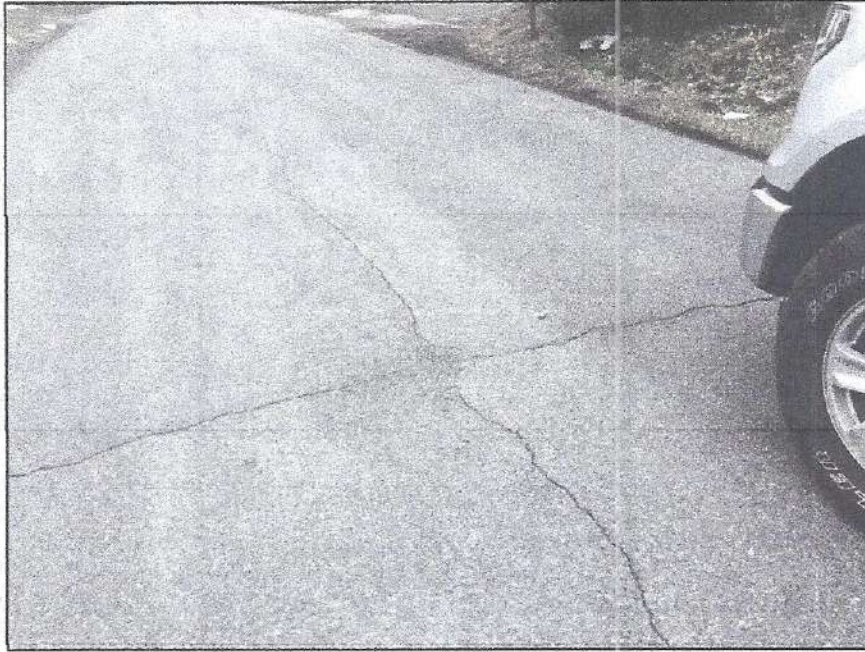
Based on visual condition, we believe that the existing pavement surface on Aarons Ave is approximately 20 years old. G&A observed medium severity block cracking, low to medium severity longitudinal and edge cracking, and low severity raveling (Photo 1 through Photo 3). This pavement distress appears to be due to general pavement age, and lack of edge support and weakened subgrade near the edge of the pavement.

1) Aarons Avenue – Medium severity block cracking

Aarons Avenue – G&A agrees that Aarons Avenue is in suitable condition to receive a mill and overlay repair. Isolated full depth repairs should be anticipated during this process in particularly distressed areas to reduce the potential for reflective cracking resulting from distressed underlying pavement materials to remain.

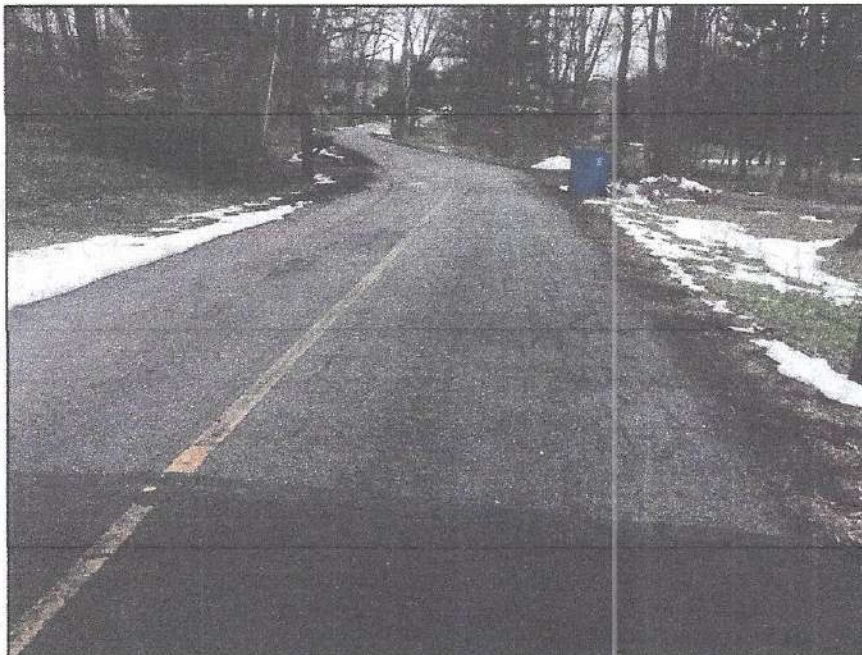
2) Aarons Avenue – Low to medium severity longitudinal and edge cracking, low severity raveling

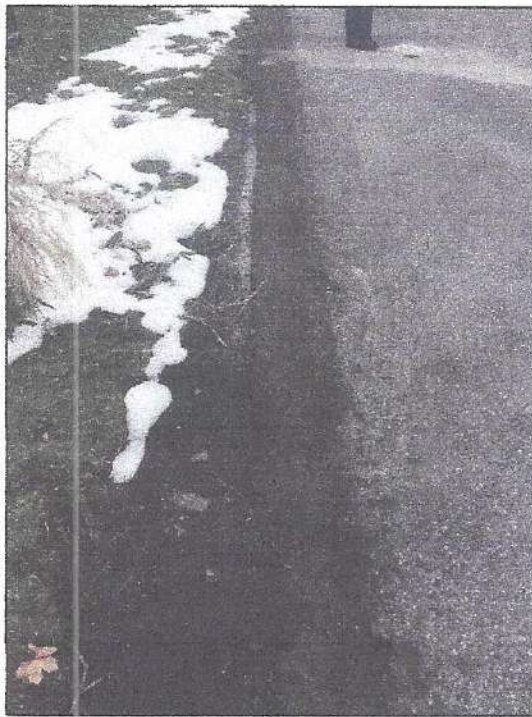
3) Aarons Avenue –Medium severity edge cracking

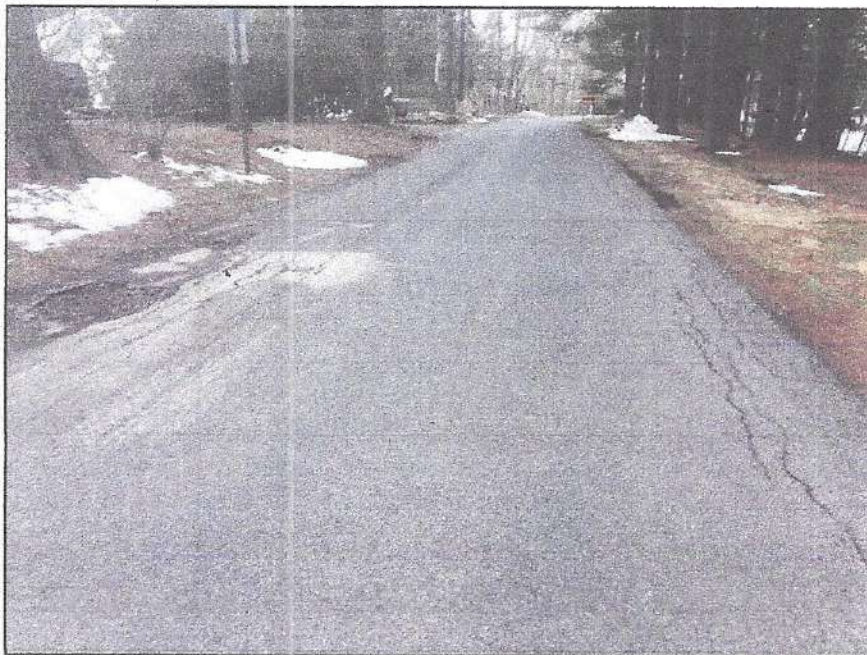
Based on visual condition, we estimate that the existing pavement surface is approximately 25 years old. G&A observed medium severity edge cracking, low severity longitudinal/transverse cracking, and low medium raveling, and medium to high severity potholes utility cut/patches (Photo 4 through Photo 8). This pavement distress appears to be due to general pavement age.

4) Mathews Avenue – Medium severity edge cracking, high severity pothole. Distress concentrated at edges of road due to poor drainage.

Mathews Avenue, Maple Lane, Maple Court – G&A recommends that Matthews Avenue, Maple Lane, and Maple Court receive full depth asphalt replacement due to the generally poor condition of these roads, the severity of distress observed, and the condition of the underlying bituminous material. We believe that a mill and overlay treatment over a poor existing pavement section would result in reflective cracking and subsequent rapid deterioration. In addition, we recommend that consideration be given to drainage improvements along these roads. Specifically, we recommend re-grading and adding inlets at the intersection of Maple Court and Maple Lane, and edge drains or concrete swales to manage stormwater runoff along Matthews Ave. These drainage improvements will improve the pavement longevity and decrease ongoing maintenance and repairs.

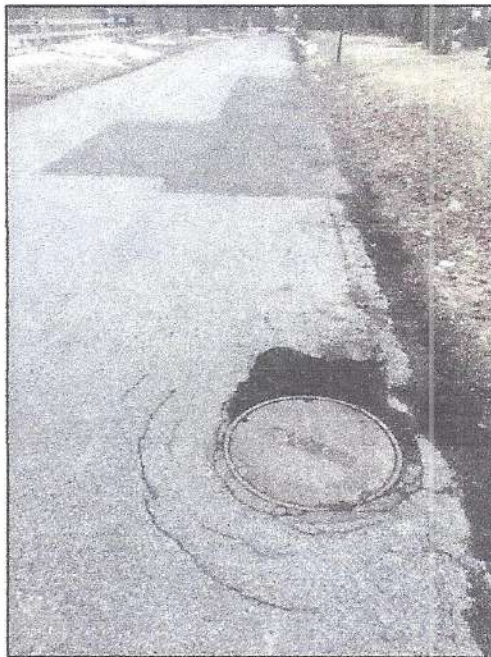
5) Mathews Avenue – Medium severity patching/utility cut, medium severity edge cracking

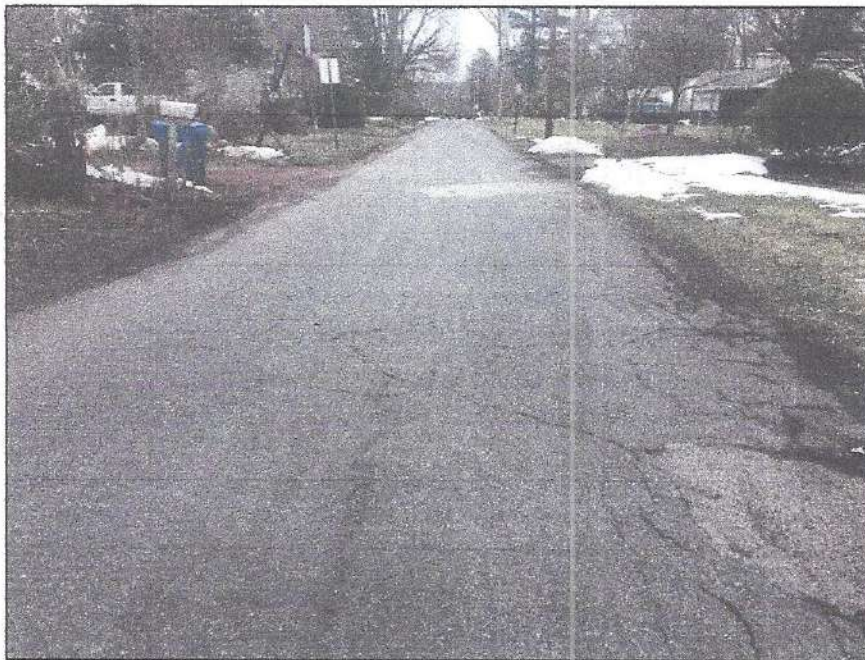
6) Mathews Avenue –High severity patching, medium severity raveling, medium severity edge cracking, low severity longitudinal cracking/block cracking

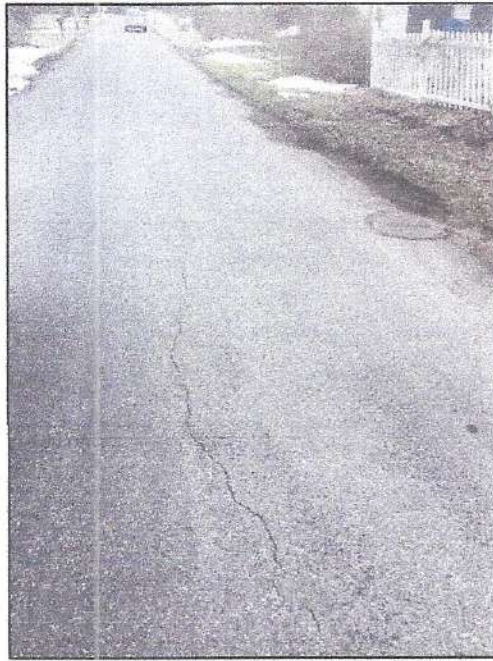
7) Mathews Avenue – Low severity longitudinal/transverse cracking

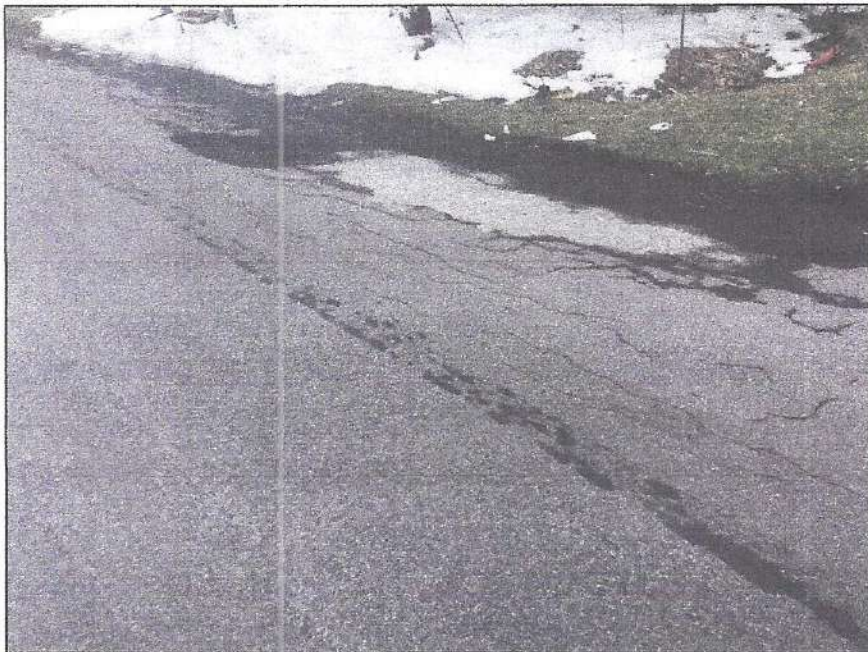
8) Mathews Avenue – Medium severity patching, low severity longitudinal cracking, and medium severity edge cracking. Repeat pavement failures due to poor drainage along edge of the road.

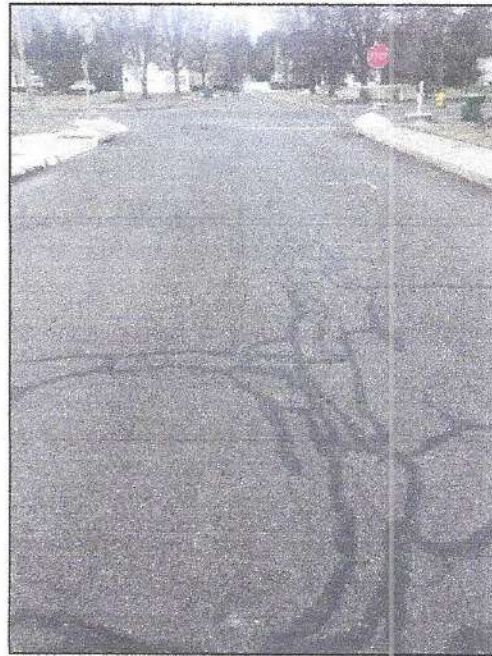
Based on visual condition, we estimate that the existing pavements are approximately 25 years old. In general, G&A observed medium severity alligator cracking, low severity longitudinal/transverse cracking, low to medium severity raveling, and medium severity utility cut/patches. (Photo 9 through Photo 13). This pavement distress appears to be due to general pavement age.

9) Maple Lane – Medium severity alligator cracking, low severity longitudinal/transverse cracking

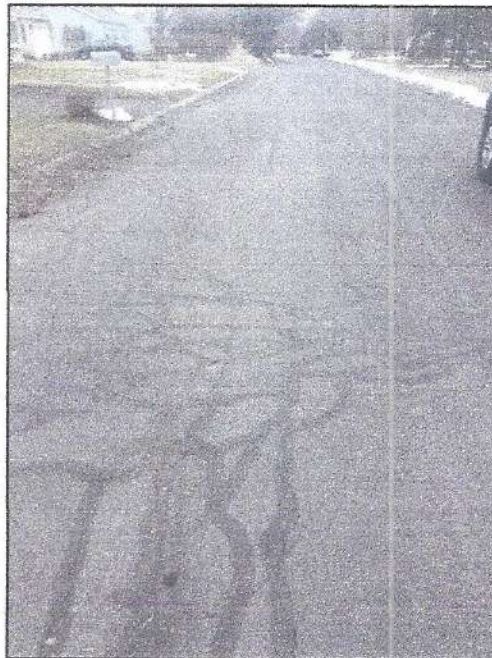
10) Maple Lane – Medium severity alligator cracking, medium severity utility patching

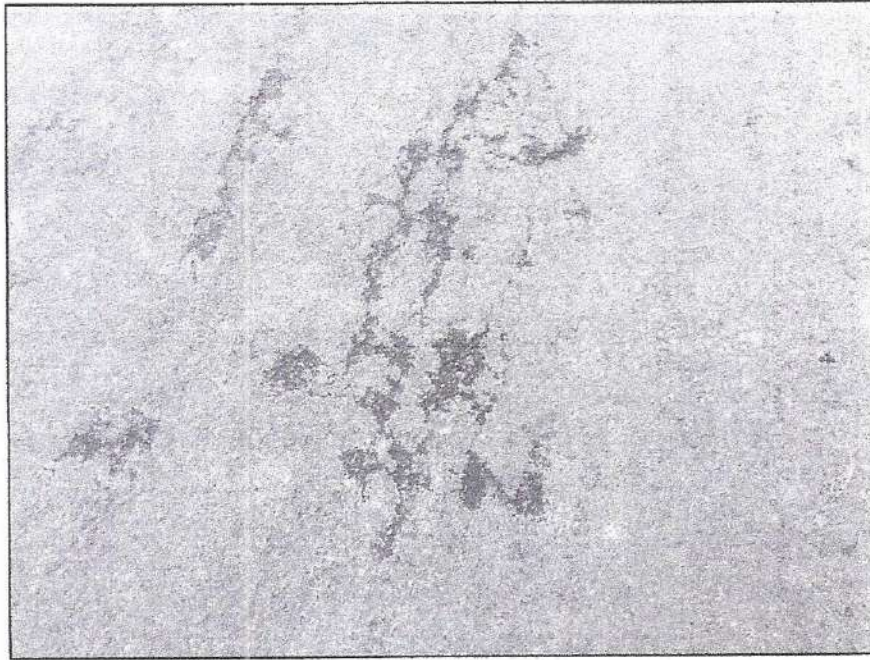
11) Maple Lane –Low to medium severity raveling

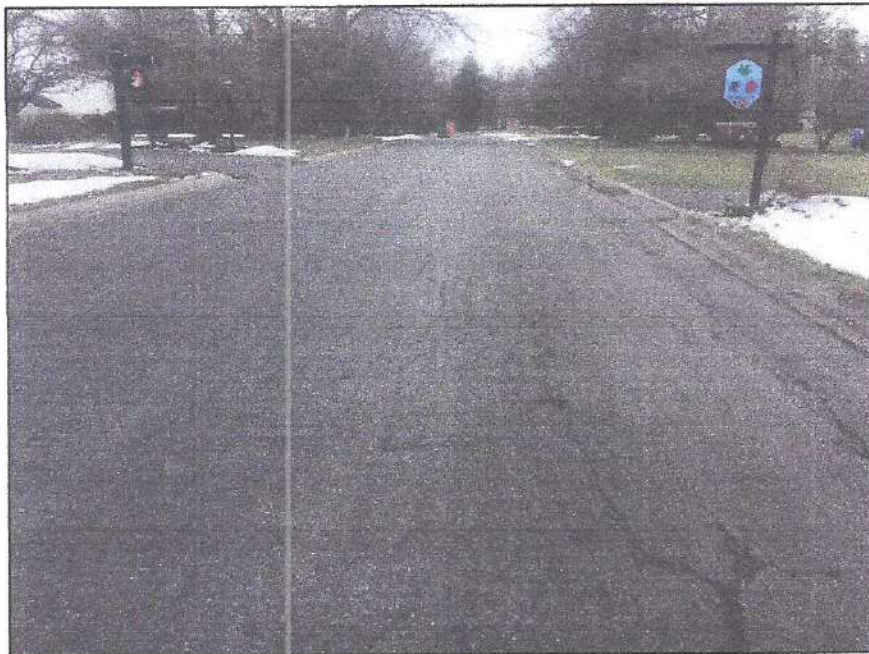
12) Maple Lane – Low severity longitudinal/transverse cracking

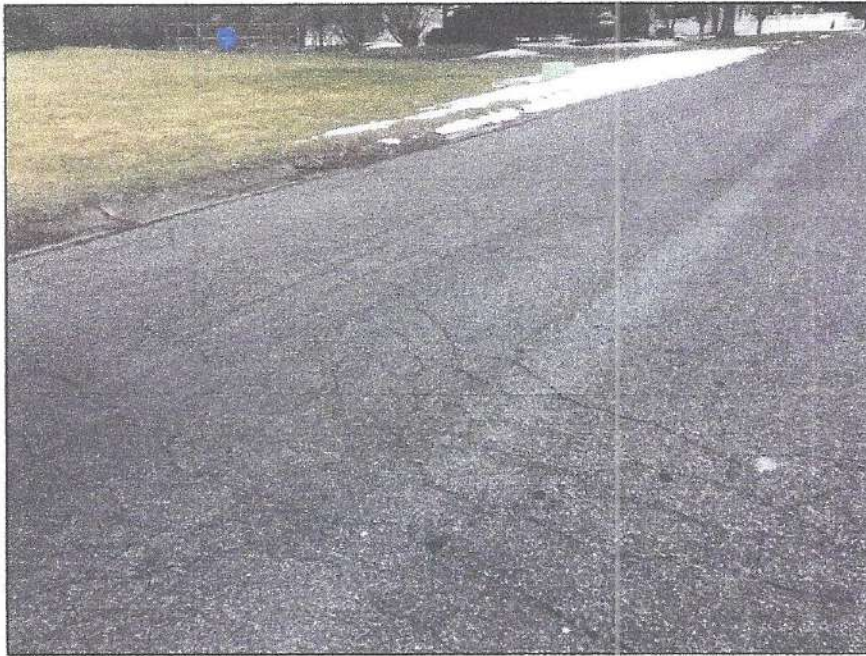
13) Maple Lane – Medium severity alligator cracking, low severity longitudinal/transverse cracking.

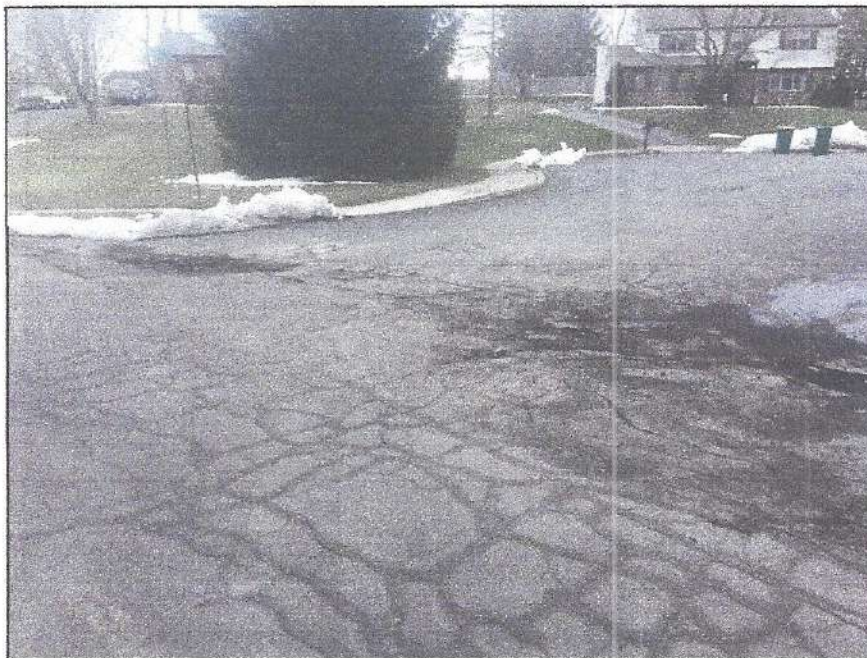
In one particular area, at the intersection of Maple Court and Maple Lane, a higher concentration of distress was observed. Here, G&A observed moderate to high severity alligator cracking, raveling, and potholes (Photo 14). This elevated degree of pavement distress appears to be the result of poor drainage at this location.

14) Maple Lane –High severity alligator cracking, high severity potholes, medium to high severity raveling. High degree of pavement distress correlated to poor drainage.
